# **Ground Penetrating Radar Survey Report:**

**Montgomery Botanical Center  
Miami, Florida  
March 2003**

Completed by Jessie Pincus in association with Mnemotrix Systems, Inc.

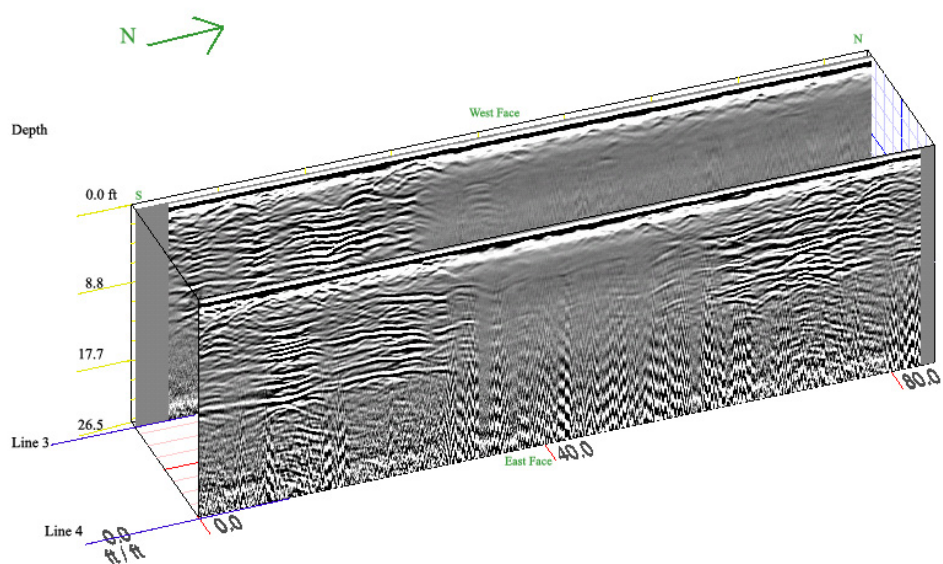
**Figure 7: Area 2B, North-South/South-North survey lines**

Area 2 (specifically 2B) shows some indications of similarly crumbling limestone which could indicate the formation of shallower minor sinkholes. Further GPR investigation would be required to confirm this postulate. Even so, any such features do not appear to be as prominent as what we are seeing in Area 1.

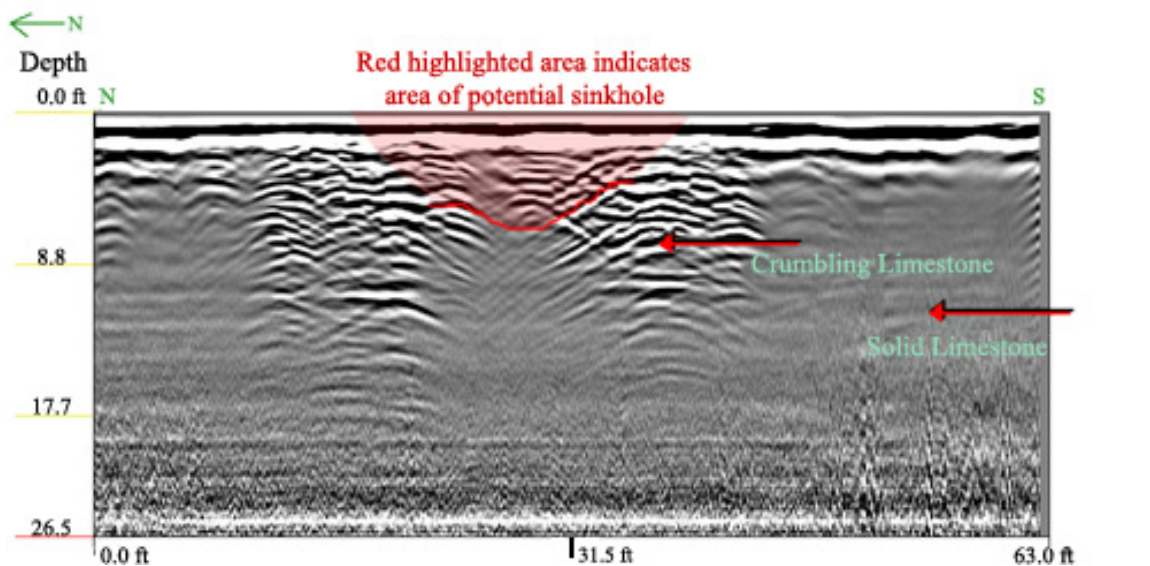
Upon close inspection of the regions of Area 1 which contained what we believe to be crumbling limestone, we found at least one clear depression which could very likely be a sinkhole. According to the dimensions on our scan, the possible sinkhole looks to be

about 25 feet in diameter, extending to ~7.5 feet below the surface. It appears to begin about 1-2 feet below the surface, so should not be difficult to excavate for confirmation.

This is illustrated in *Figure 10* below.

**Figure 10: Enlarged View of Possible Sinkhole Area as found in Area 1A (Line 2 of the North-South survey lines).**

If the location and dimensions of the potential sinkhole we have identified are of adequate proportion to satisfy the Botanical Center's requirements, we would definitely recommend further investigation of this area. If it would be desirable to minimize any invasive disruption of property, we can come in and survey the identified area more intensively in order to locate the most precise point in which to excavate, and to determine the appropriateness of this feature for your needs.

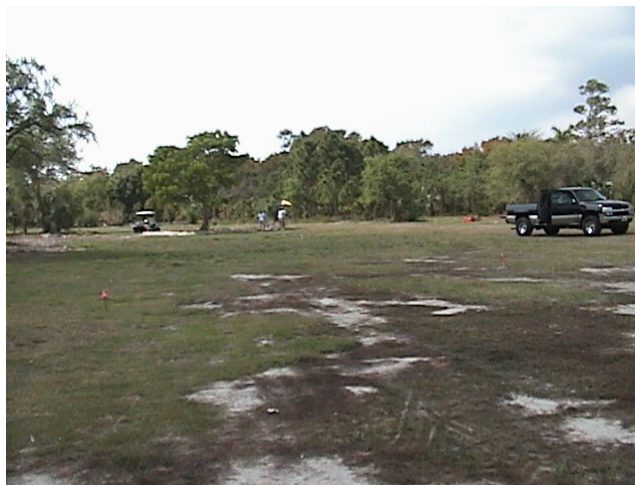
In the photo below, survey Area 3 is in the distance, while survey Area 2 is in the foreground. Area 1 is to the left, containing the potential sinkhole area.

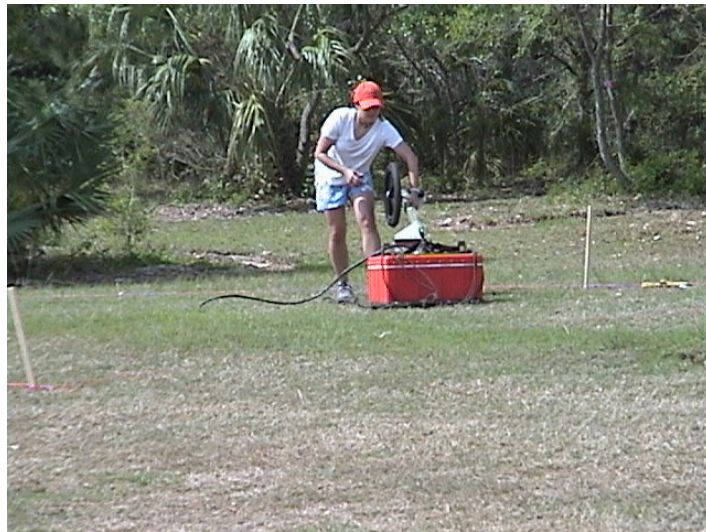
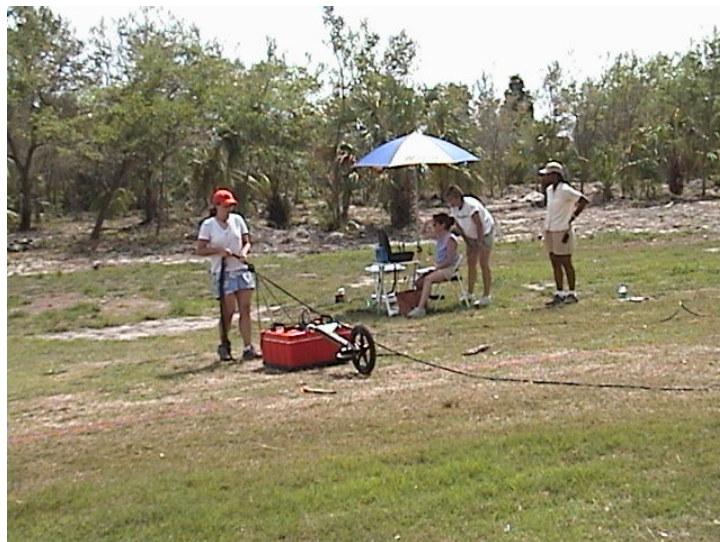
The photos below show Mnemotrix Survey Team operating the GPR equipment onsite at Montgomery Botanical Center, March, 2003. Montgomery staff assist.
